VIRGINIA HOME INSPECTIONS
P.O. BOX 586
CHINCOTEAGUE ISLAND, VA 23336
PHONE 757 336-3450
Inspector1@verizon.net

Virginia Home Inspections
AGREEMENT FOR HOME INSPECTION SERVICES

Sample Report

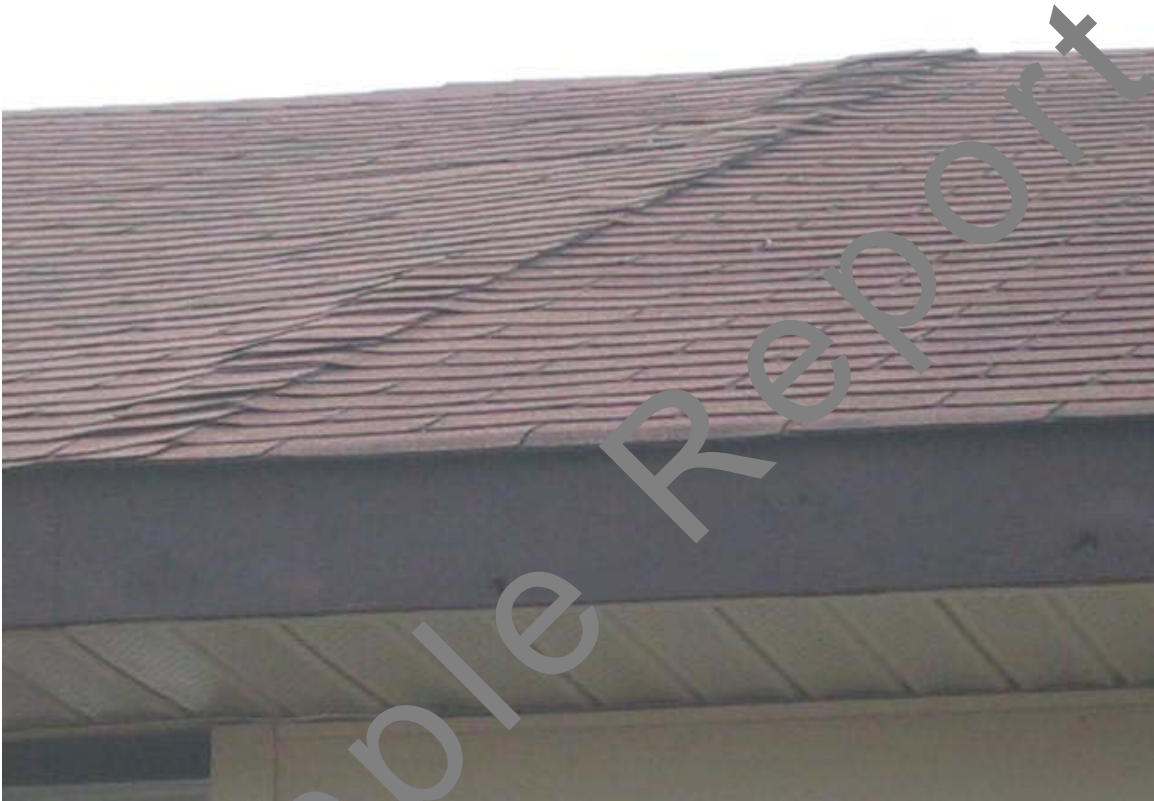
1. THERE IS A HUMP IN THE SHINGLES ON BOTH SIDES OF THE BREEZEWAY, THIS IS WHERE THE ROOF IS NOT EVEN BETWEEN THE MAIN HOUSE AND THE GARAGE.

Hump in the roofing shingles over the breezeway.

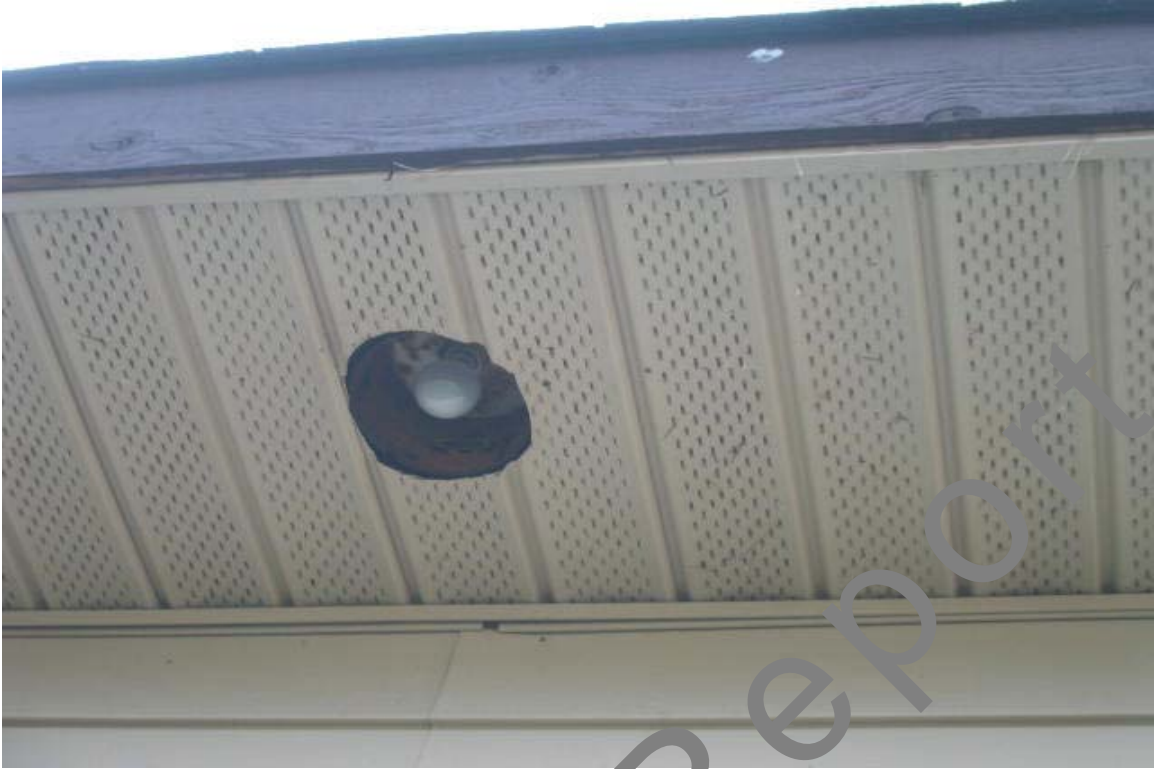
4. THERE IS ONE SPINDLE MISSING ON THE RIGHT SIDE OF THE FRONT PORCH.

THERE IS A COVER MISSING ON THE EXTERIOR SOFFIT LIGHT ON THE FRONT OF THE HOUSE.

Light fixture cover missing on the front.
Rail spindle missing on the front porch.

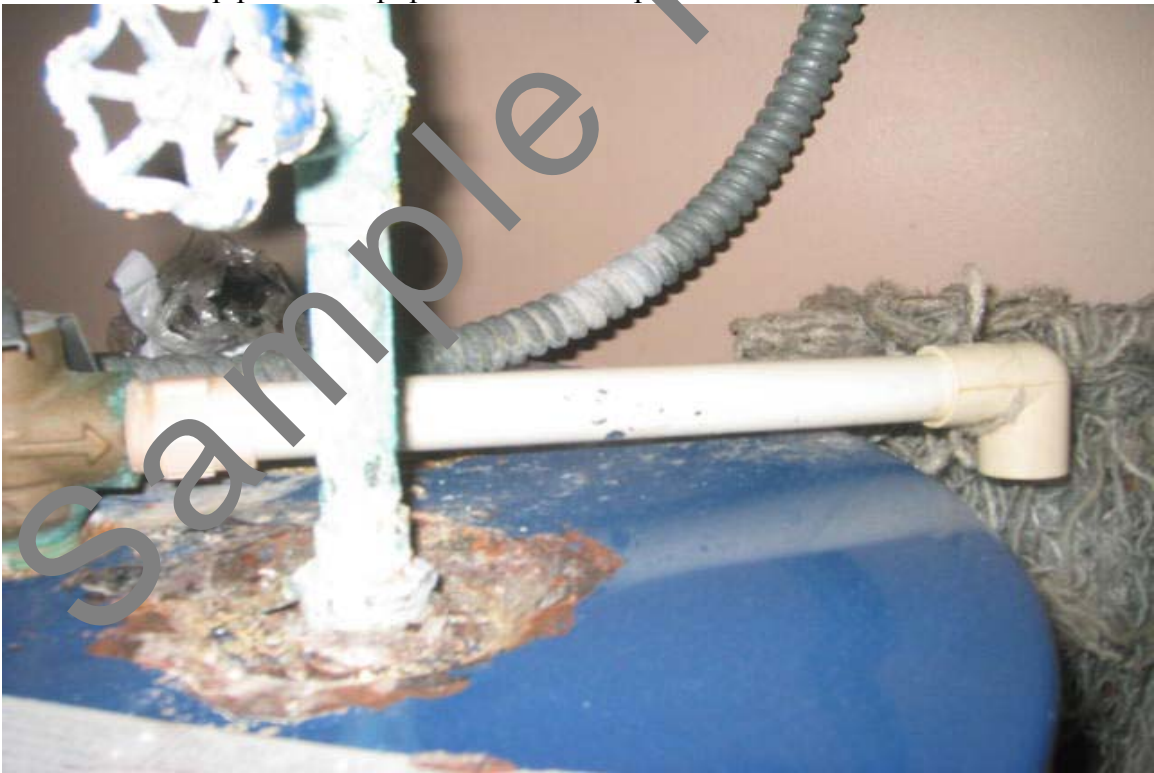
THE HOT WATER HEATER IS SHOWING RUST AROUND THE BOTTOM OF THE CABINET, CONSIDERATION SHOULD BE TO REPLACE THIS BEFORE IT LEAKS AND CAUSES DAMAGE.

Rust around the bottom of the hot water heater.
Some rot damage on the left side of the first room on the right, floor and jamb.

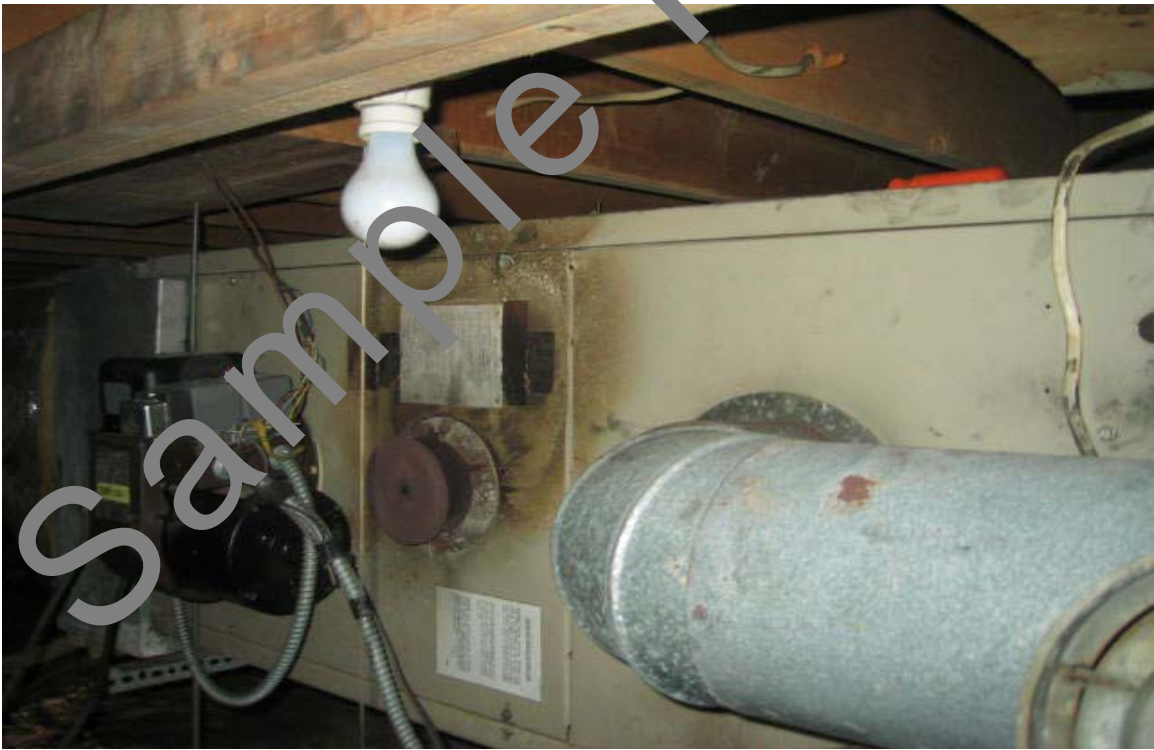
21. THE DRAIN LINE FOR THE FURNACE HAS BROKEN AND NEEDS TO BE REPAIRED.

Condensation line has broken.
The pipe sticking up on the right side appears to be the way the Jacuzzi is drained.

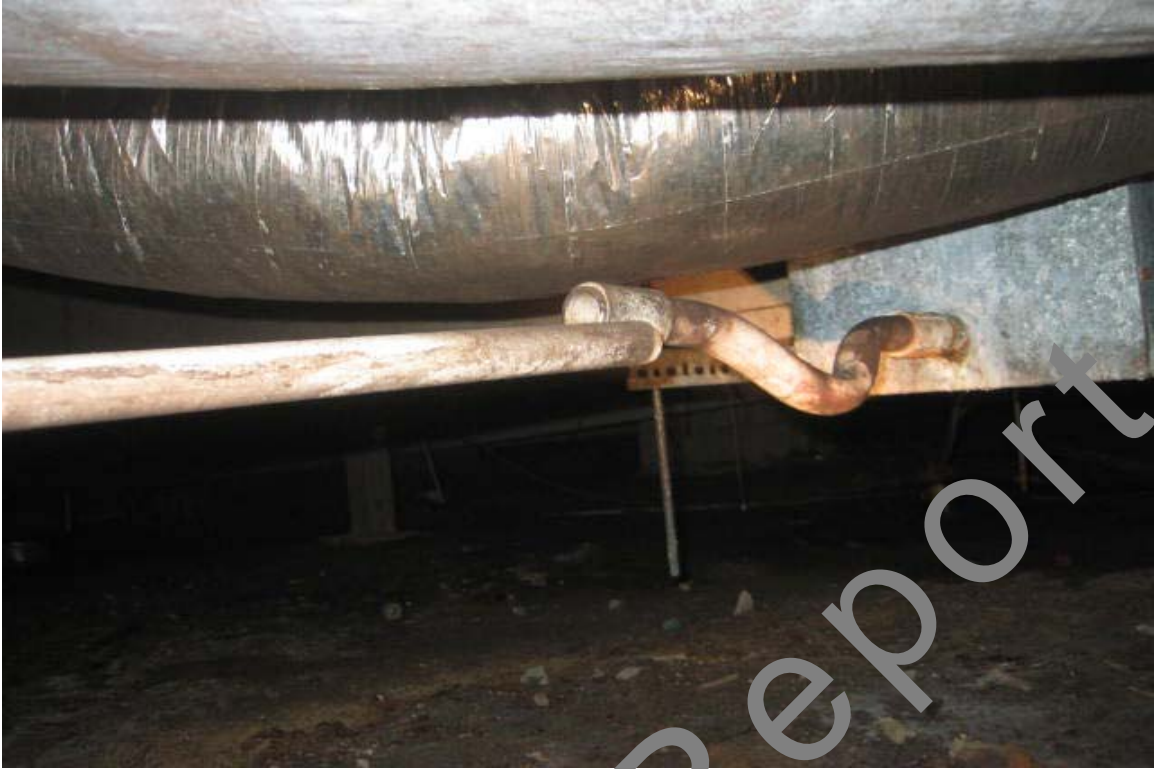
IT ALSO APPEARS THAT WHEN THE JUCUZZI IS DRAINED THERE NEEDS TO BE A HOSE CONNECTED UNDER THE HOUSE.
